Power Brake Exchange

Technical Bulletin TB - 2

Clogged Power Steering Reservoir Filter - Toyota & Lexus

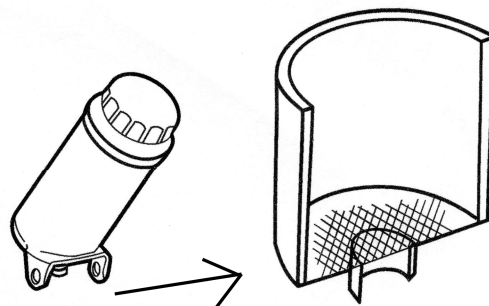
- USE:** Toyota and Lexus vehicles with power steering.
- PROBLEM:** Noise coming from the power steering pump or reduced assist from the power steering system.
- REASON:** Noise or reduced assist may be caused by restriction in the power steering fluid reservoir. Most Toyota/Lexus-style reservoirs have a filter screen at the bottom. Over a period of time this filter could get clogged causing the restriction of fluid.
- ANSWER:** Replace any hose that shows signs of cracking or internal deterioration. Thoroughly flush the power steering system; then remove the reservoir for cleaning as follows:

Cut-away of a typical reservoir showing internal filter screen

1. Clean the exterior and interior of reservoir with new power steering fluid or suitable solvent.
2. Blow off the filter screen using pressurized air until restriction or clog is removed.
3. Using a flashlight, check to make sure that the filter screen is free of debris. Note: Contamination may be an indication of internal breakdown of hoses, which must be replaced before operating the vehicle. Failure to replace bad hoses could damage both the pump and steering unit.
4. Reinstall reservoir, referring to the service manual for tightening specs and bleeding procedures.
