Power Brake Exchange

260 Phelan Ave. San Jose, Ca. 95112 Ph. (408) 292-1305 Fax (408) 294-6817
Technical Bulletin – TB3

TOYOTA RACK & PINION PORT LEAKS

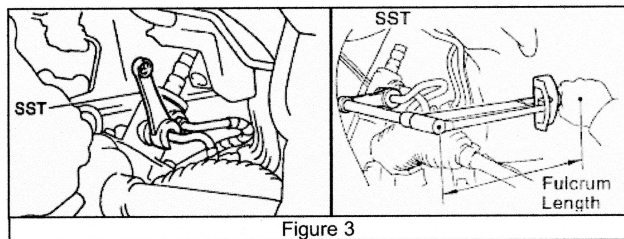
- USE:** Toyota cars and trucks 1988 to 2003,
- PROBLEM:** Replacement rack and pinion leaks from the pressure or return port fittings at the housing (see figure 1).

- REASON:** The original fitting O-ring seals were reused or fittings improperly tightened. High heat and pressure make the old seals hard and brittle - this is known as "compression set". Reusing seals causes leaks because they are unable to conform to the sealing surface. To compound the problem, a technician may assume that the leakage can be stopped if more torque is applied to the fittings - this assumption is INCORRECT. The seal on this type of fitting is held in place and activated by the pre-formed flare and grommet in the hydraulic line itself (see figure 2). Over-tightening the fittings can lead to stripped port threads and cracked castings.

- ANSWER:**
1. Replace original O-rings with the supplied new O-rings found in the installation kit attached to your rack & pinion.
 2. Follow all OE torque and installation specifications and practices (Reference the vehicle's OE Service Manual for installation specifications).

3. Use the correct tools for the installation. For these applications, Toyota suggests certain tools (SST, see figure 3 for typical installation) that will assist and ensure correct installation of this rack & pinion. Refer to the vehicle OE Service Manual for individual installation specifications.
