# Power Brake Exchange

260 Phelan Ave. San Jose, Ca. 95112 Ph. (408) 292-1305 Fax (408) 294-6817  
**Technical Bulletin – TB4**

## MIS-DIAGNOSED POWER STEERING PUMP NOISE

**Use:** 1992-93 CHEVROLET AND GMC TRUCK C/K, S/T MODELS  
1992-93 OLDSMOBILE BRAVADA WITH 4.3L, 5.0L, 5.7L  
ENGINES

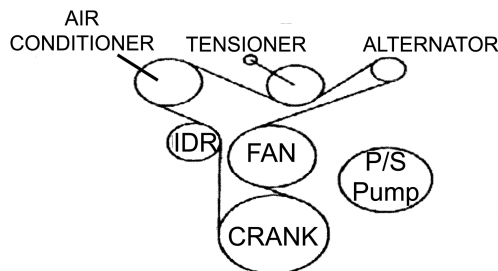
**PROBLEM:** A whine noise emanating at the front of the vehicle that appears to be coming from the power steering pump.

**REASON:** The noise may actually be the result of a failed bearing in the alternator.

FIG. 1 Isolating the power steering pump from the accessory drive.

1. Isolate the power steering pump from the alternator by installing an accessory drive belt off of a 3.4L equipped 1993 or 1994 Camaro or Firebird. Install the diagnosis belt as shown in FIG. 1.
2. Run the engine and listen for the noise. Do not drive the vehicle with this belt attached. If the noise is gone, the power steering system is most likely at fault. If the noise remains, proceed to diagnose the remaining elements of the accessory drive including the generator.
3. After the noise is successfully corrected, remove the accessory drive belt used for diagnosis.
4. Install the original accessory drive belt as shown in FIG. 2.

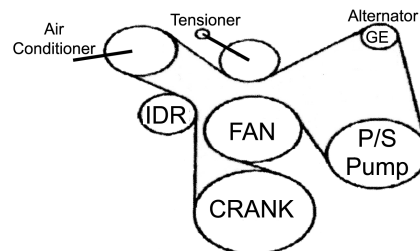
FIG. 2 Belt routing for 4.3L/5.0L/5.7L Engines.
